**DEPARTMENT OF TRANSPORTATION**

Contract #: 04-0120F4Cty: SF/ALA Rte: 80 PM: 13.2/13.9File #: 99.28**WELDING INSPECTION REPORT****Resident Engineer:**Siegenthaler, Peter**Address:** 333 Burma Road**City:** Oakland, CA 94607**Report No:** WIR-018275**Date Inspected:** 23-Nov-2010**Project Name:** SAS Superstructure**OSM Arrival Time:** 700**Prime Contractor:** American Bridge/Fluor Enterprises, a JV**OSM Departure Time:** 1900**Contractor:** Zhenhua Port Machinery Company, Ltd (ZPMC)**Location:** Shanghai, China

Orthotropic Box Girder (OBG) at Trial Assembly Areas

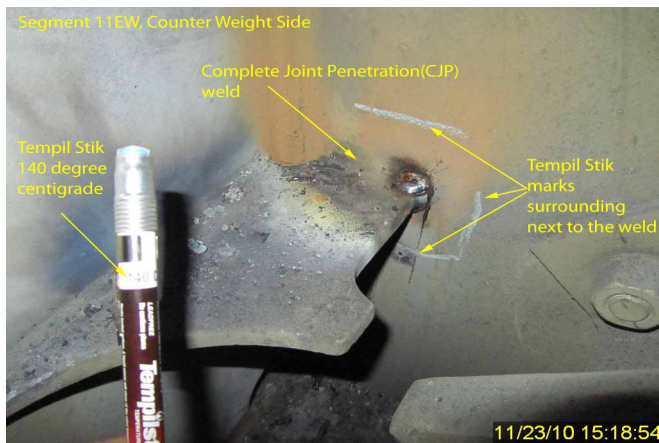
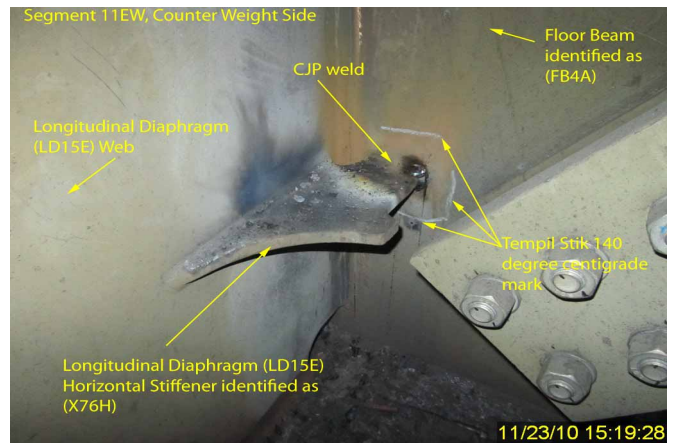
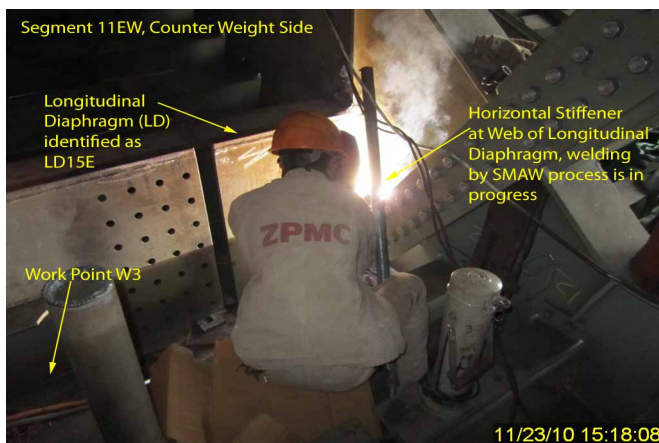
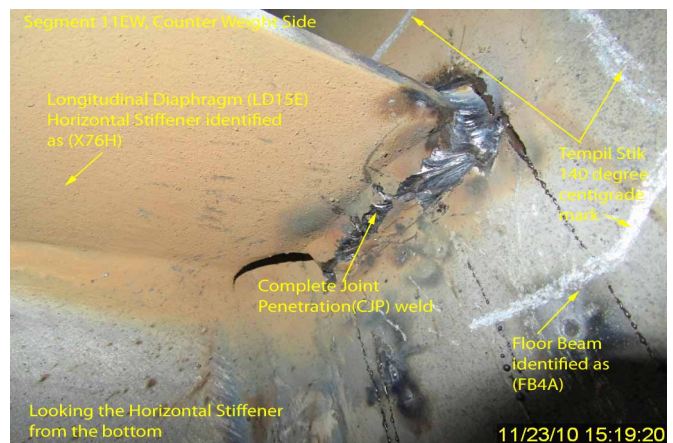
Incident Report generated at Segment 11EW (Longitudinal Diaphragm)

This Quality Assurance (QA) Inspector wrote an Incident Report for welding horizontal stiffener at web of Longitudinal Diaphragm (LD) to the Floor Beam at Segment 11EW at PP 107 at work point W3 without pre-heating and observed pre-heat temperature does not meet the requirements as laid down by New Weld Procedure (Rager/McQuaid). Please reference the Incident Report # 04-0120F4\_TL-15\_B278\_11-23-10\_11EW\_No Preheat\_LD\_Stiffener\_W3\_Panel Point\_PP107 dated November 23, 2010 for further detail.

Please reference the pictures attached for more comprehensive details.
